Manhole Inspection Summary

Manhole # **S29C__004MH**

Insp Date: **4/3/08 2:51 PM**

Location Address: **SARATOGA ST**

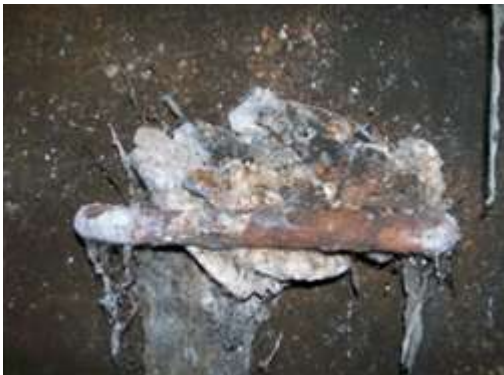
Defect 1

Surcharge ☒ **Evidence Of Surcharge** Depth: **11** (ft.) ☐ Active Surcharge Present

EVIDENCE OF SURCHARGE

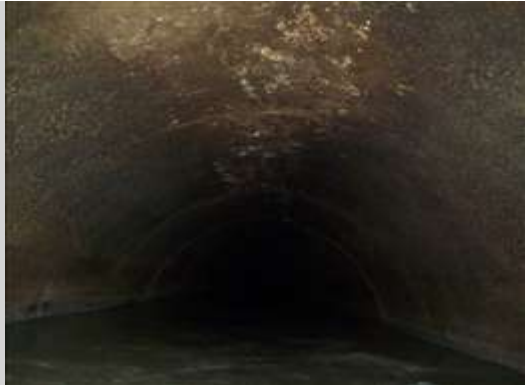
12 O'Clock Outflow

72 in. Circular Gravity Sewer
Pipe Out @ 12 O'Clock

Pipe Height: **57.6** (in.) Rod and Bar
Pipe Material: **Concrete** ☐ Pipe Lined
Invert Depth: **18.69** (ft.) Flow Characteristics: **Fast**
Deposits: ☒ None ☐ Mud ☐ Sludge ☐ Debris ☐ Grease
Silt Depth: (in.) Deposits Extent:
Infiltration: **None** Pipe Seal Cond: **Sound**

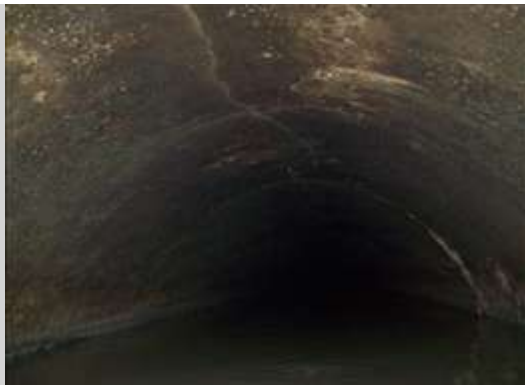
6 O'Clock Inflow

72 in. Circular Gravity Sewer
Pipe In @ 6 O'Clock

Pipe Height: **56.4** (in.) Rod and Bar
Pipe Material: **Concrete** ☐ Pipe Lined
Invert Depth: **18.67** (ft.) Flow Characteristics: **Slow**
Deposits: ☒ None ☐ Mud ☐ Sludge ☐ Debris ☐ Grease
Silt Depth: (in.) Deposits Extent:
Infiltration: **None** Pipe Seal Cond: **Sound**
